RE: Letter of Permission (LOP), Emergency Maintenance and Rehabilitation of the Existing Revetment, Jekyll Island, Glynn, Georgia

Project: Jekyll Island Emergency NWP-3 Revetment Maintenance

Owner: Jekyll Island Authority

Representative Site Photographs
Jekyll Island Revetment Maintenance and Repair

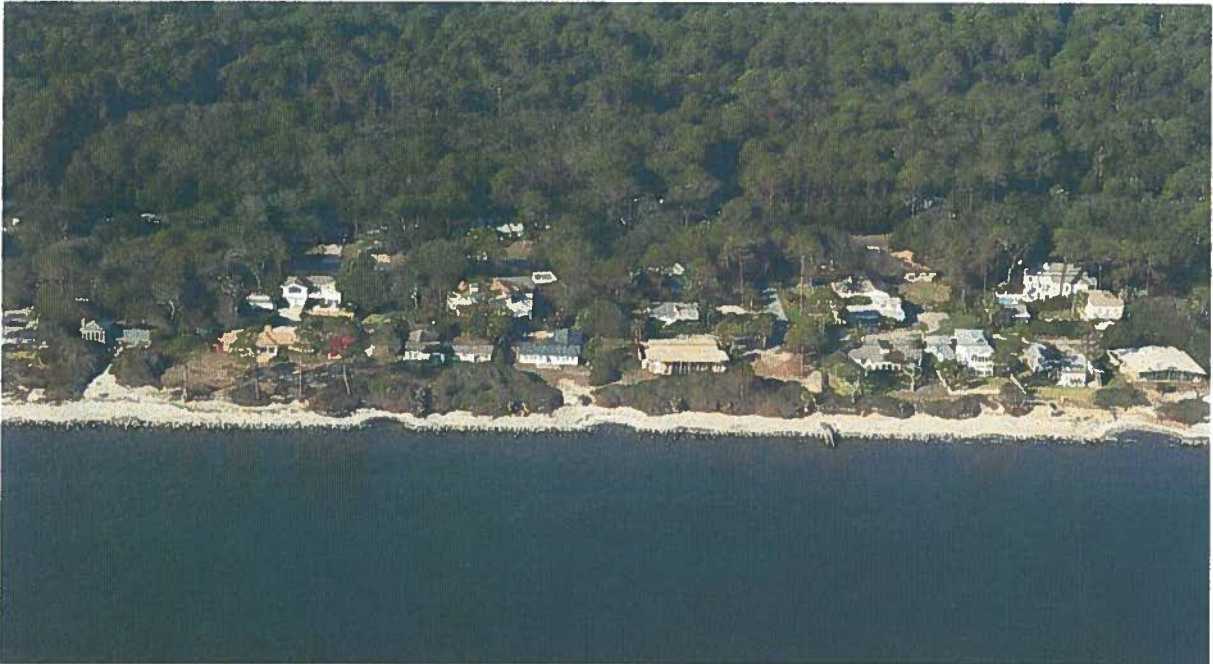
Albright Lane area (Zone D) photo during a "king" tide, showing penetration of water landward of revetment where the crest is low (post-hurricane Matthew photo)

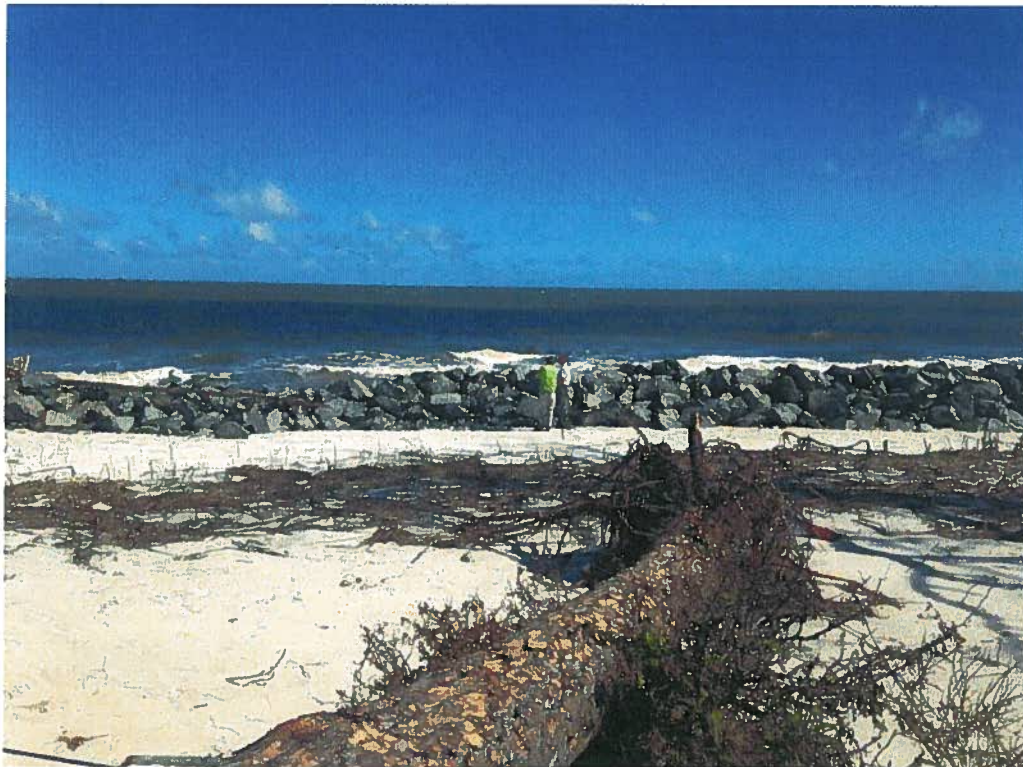
Photo showing uneven revetment crest elevation, with south (right) closer to original design versus low depression north (left)

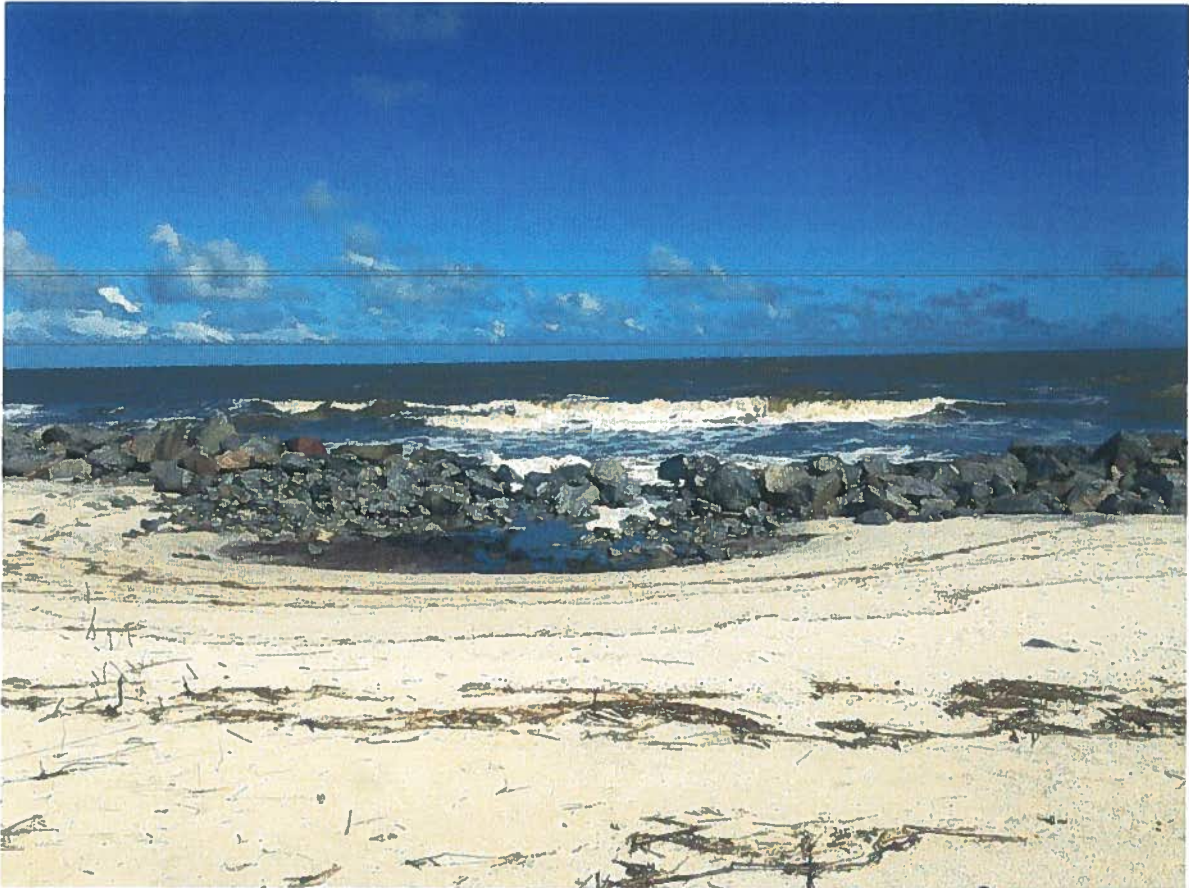
Locally damaged revetment crest section with ponding landward of the structure (10/13/17). Water level ~ MHW (+2.6 NAVD88) at the time of the photo.

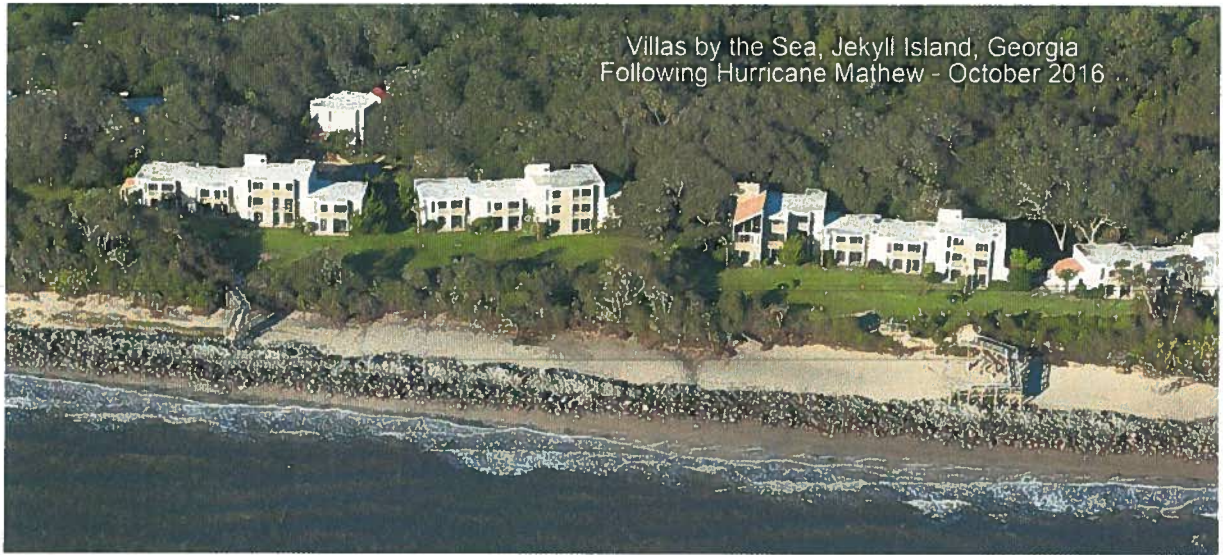
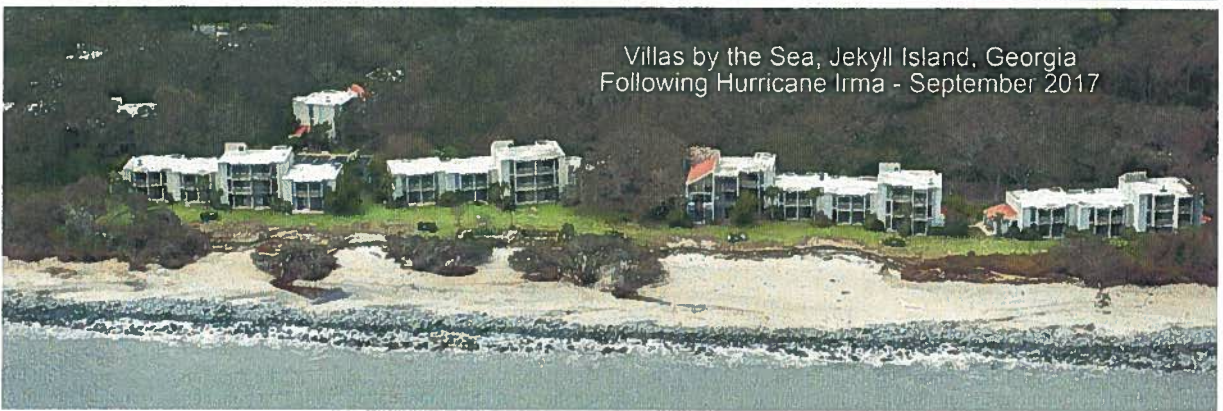
Villas By The Sea aerial comparison of Post-Matthew (top) and Post-Irma (bottom) upland erosion and dune/vegetation loss

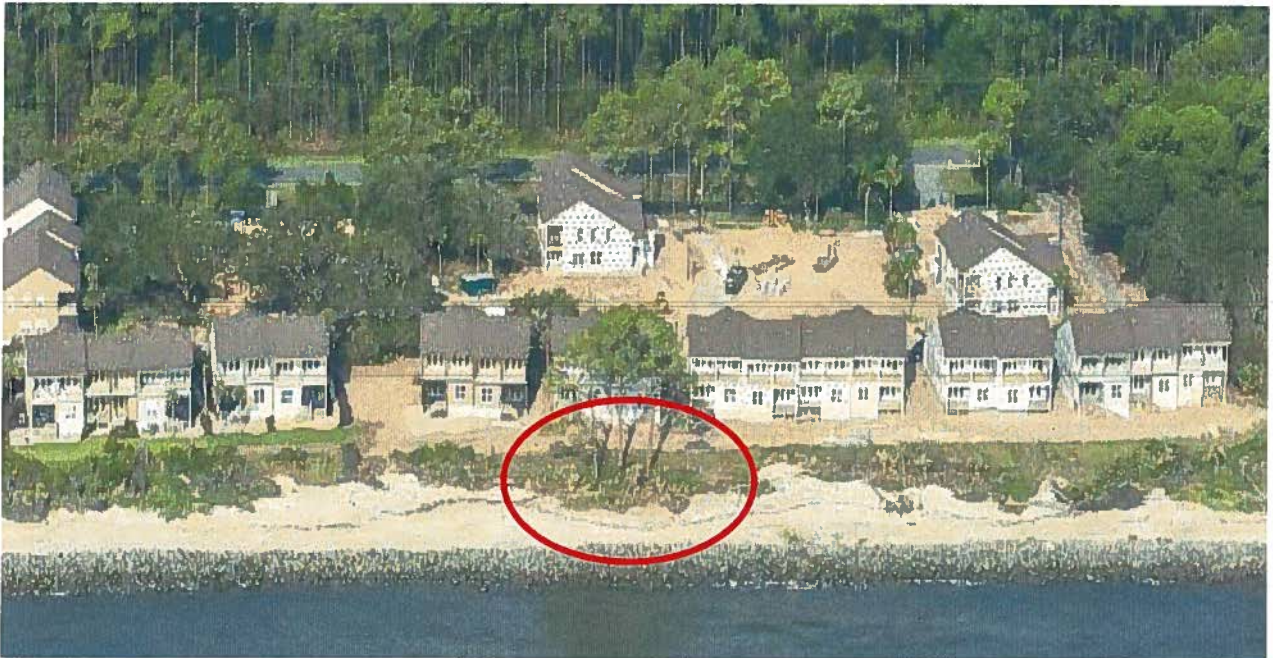
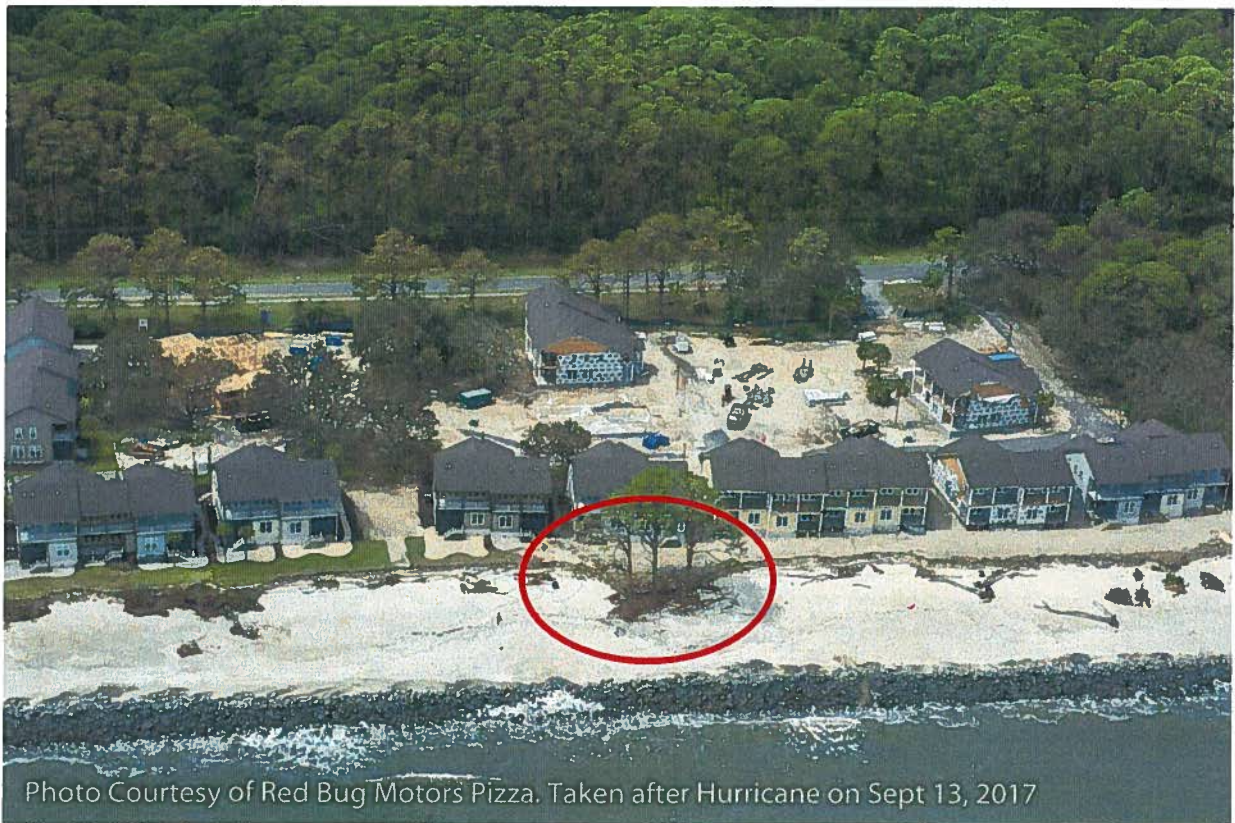
The Cottages aerial comparison of Post-Matthew (top) and Post-Irma (bottom) upland erosion and dune/vegetation loss. Note circled tree group for reference.

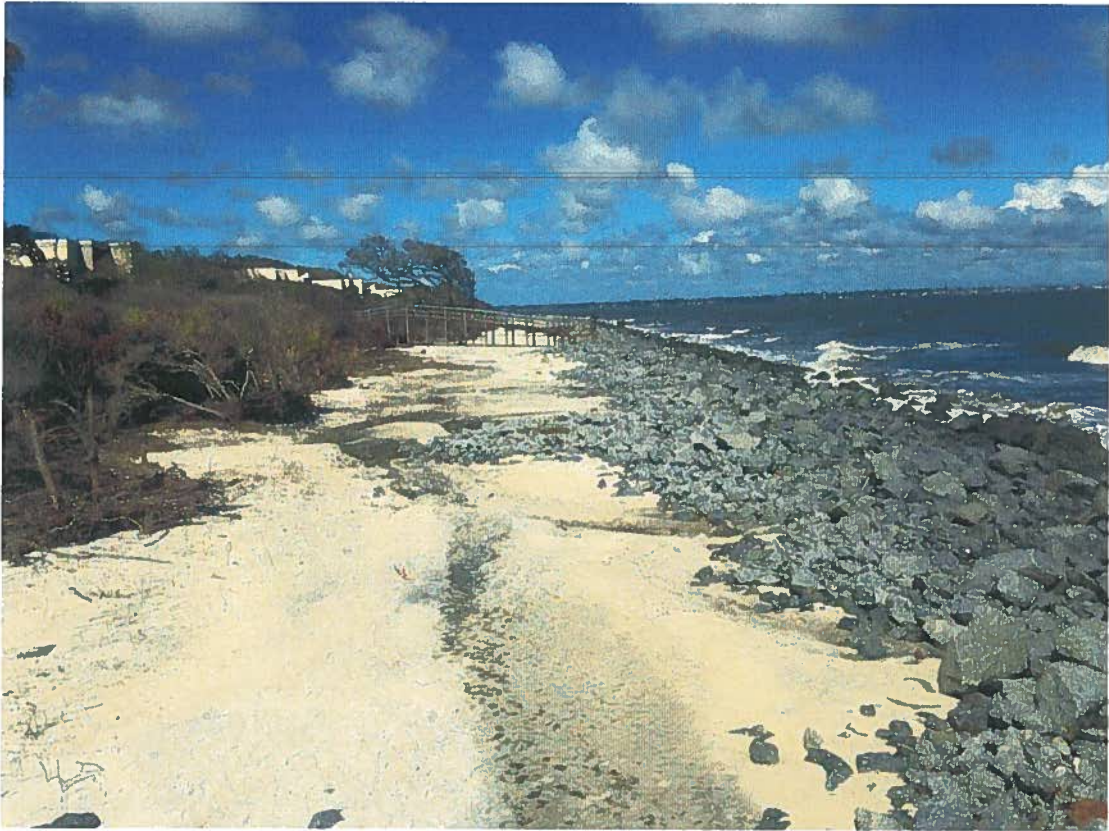
Typical revetment damage, scattered small stone, and dune/upland erosion post-Irma, Villas by the Sea (10/13/17)

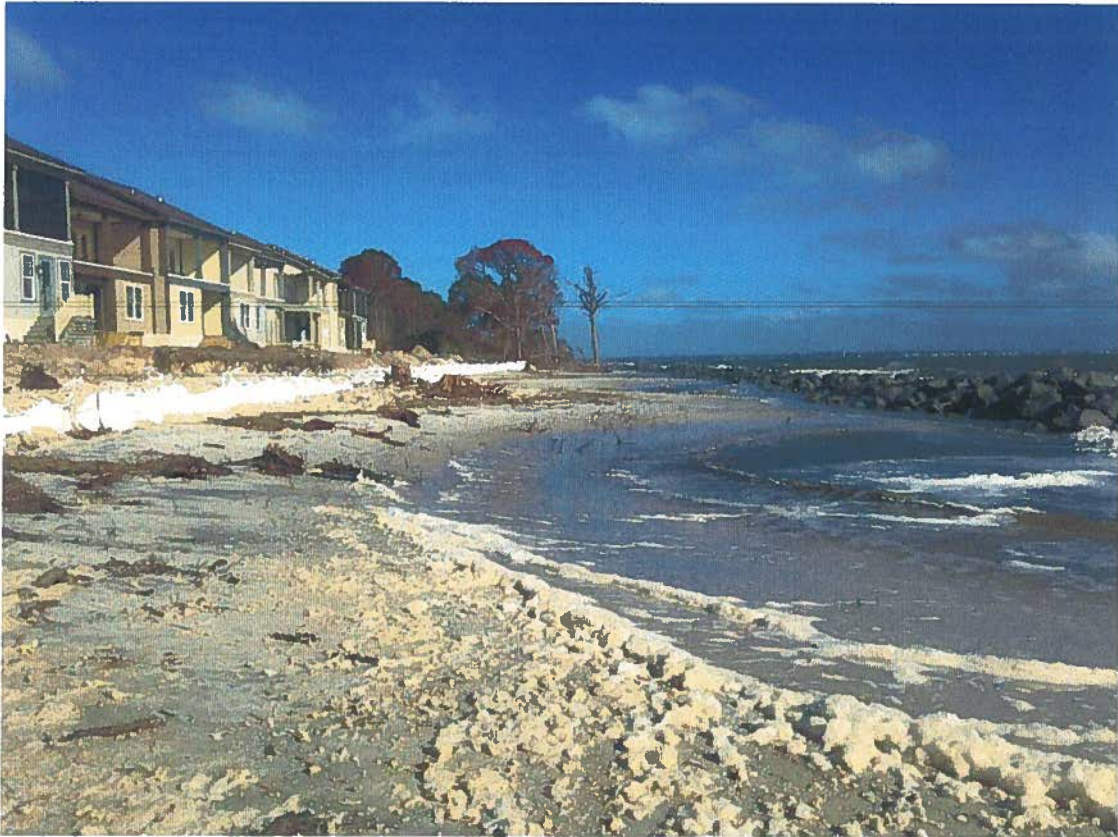
Post-Irma conditions at The Cottages during a “king” tide (10/19/17). Erosion landward of the revetment is apparent along with temporary sandbag scarp stabilization measures.

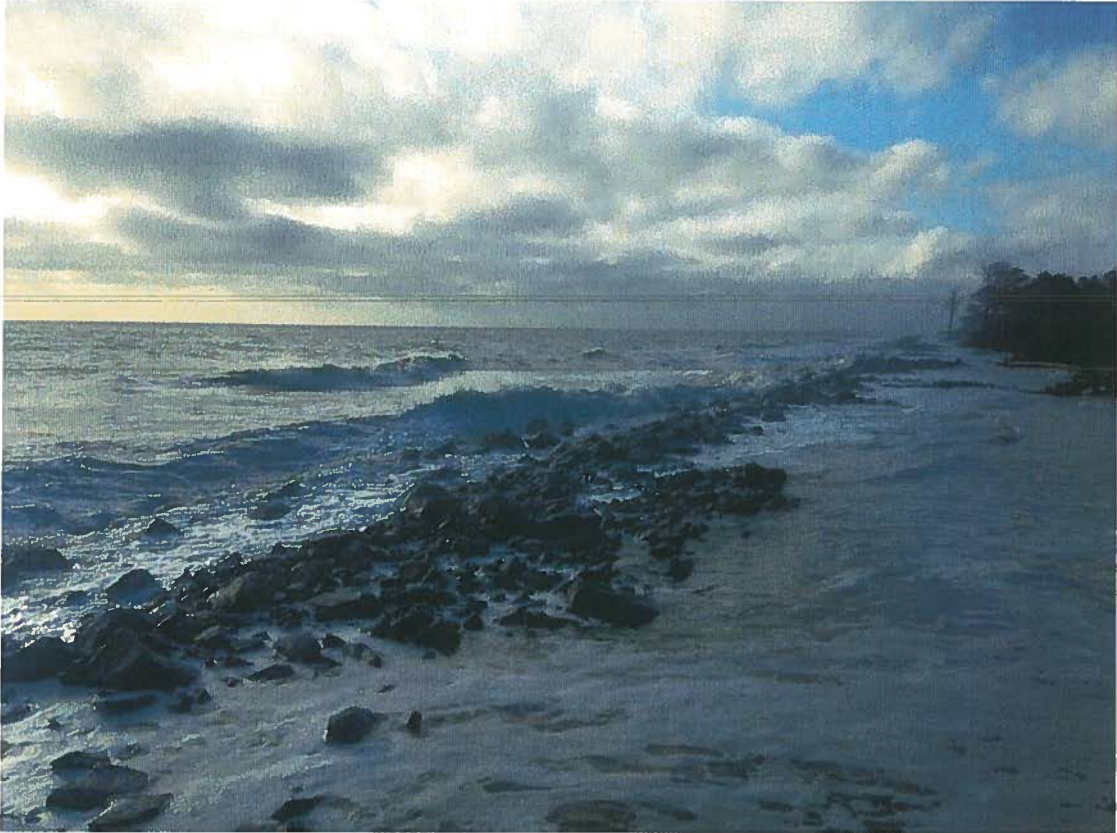
Wave action overtopping a low section of existing revetment during a “king” tide (10/19/17). Note large percentage of small stone.

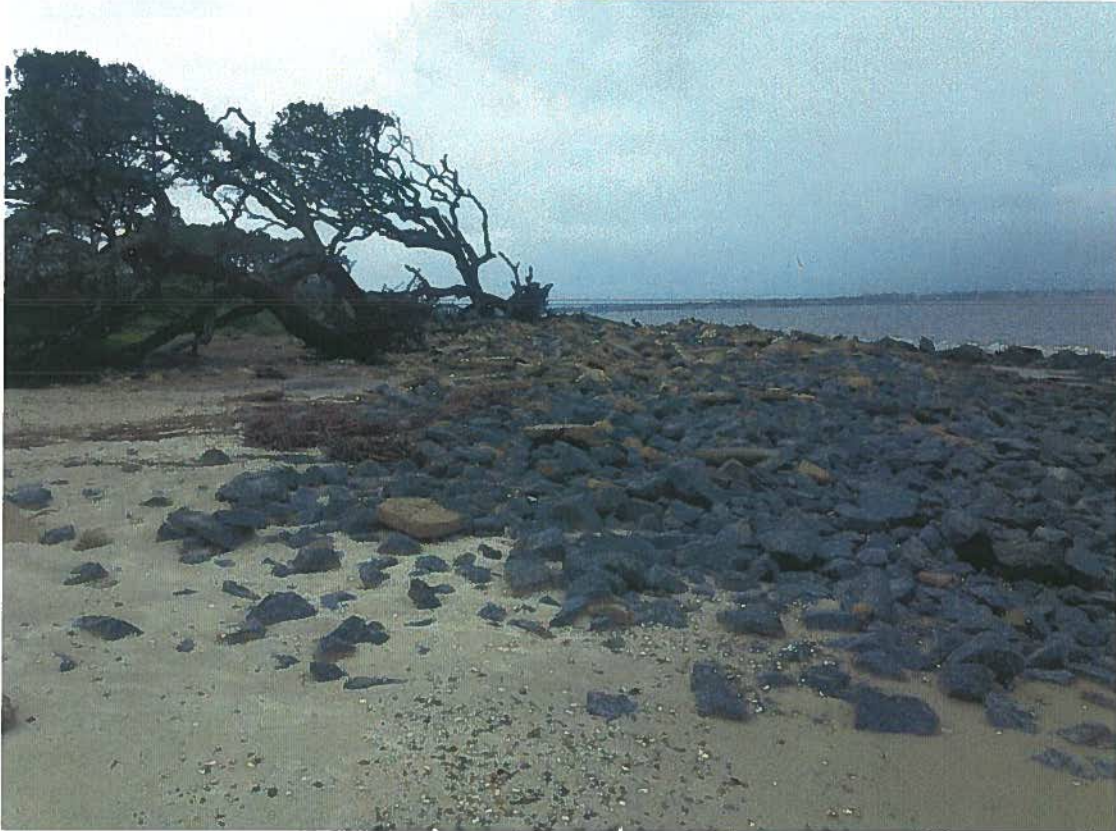
Photo of widely scattered small stone near north project limit (north of Villas by the Sea, south end of Driftwood Beach). Photo taken at low tide, 8/21/17

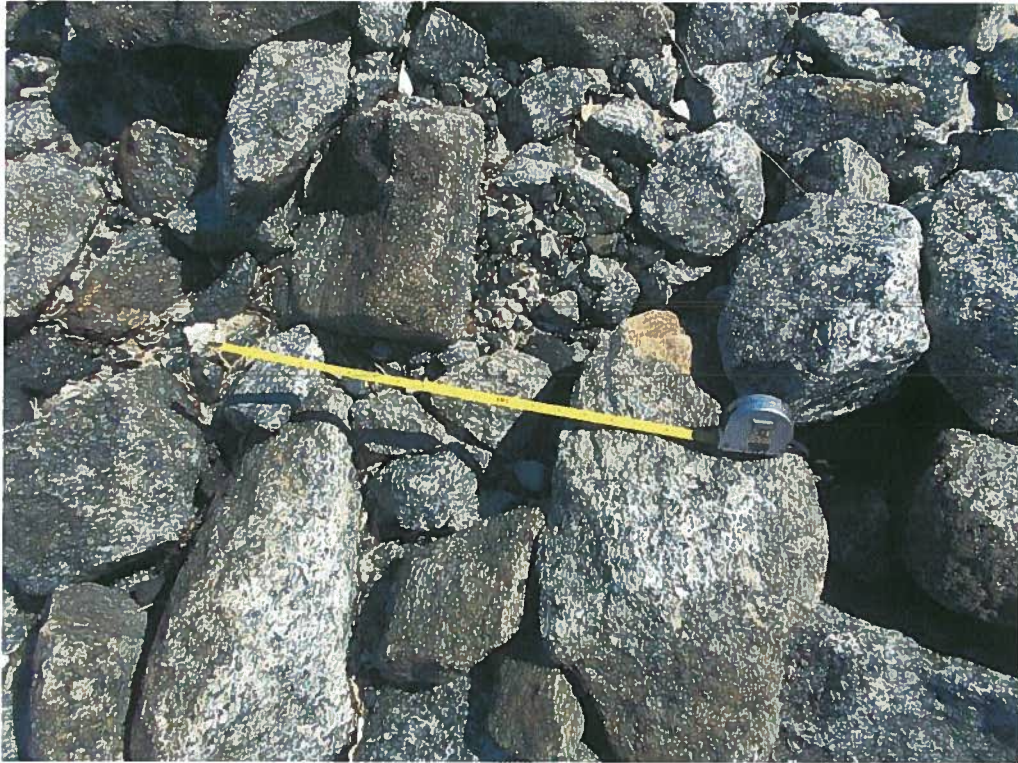
Distribution of existing stone near north limit of revetment

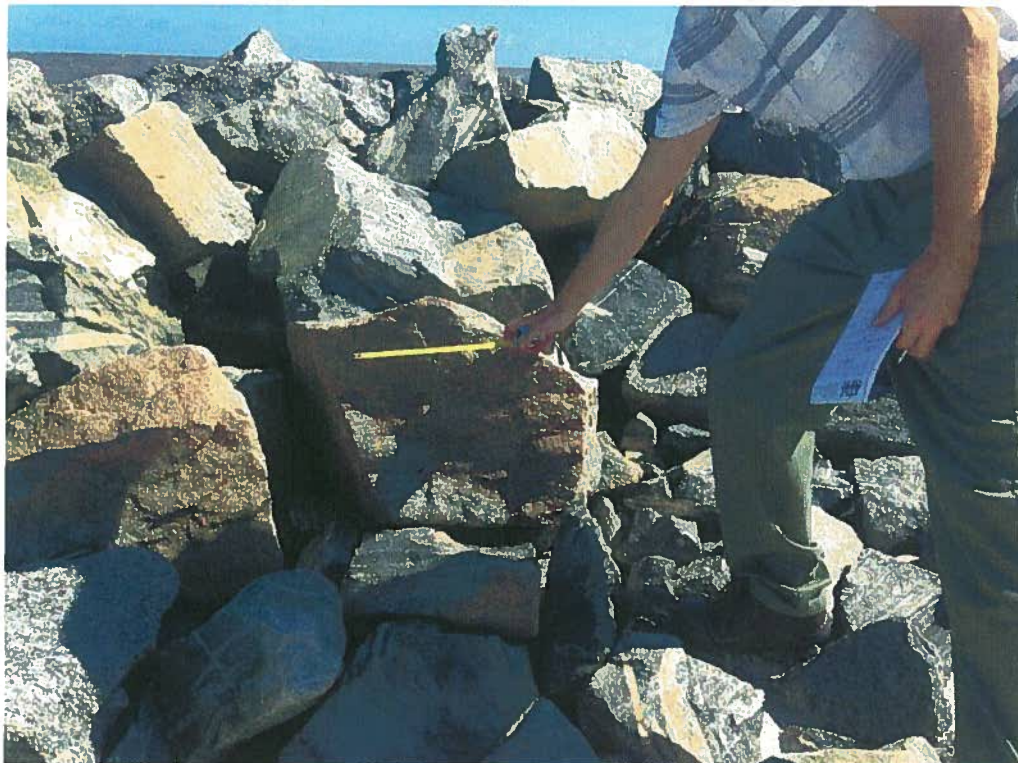
Typical rock size distribution in a fair condition section of the revetment
