Map of existing structures at Timmons River inshore artificial reef with side scan sonar imagery taken at high tide on June 29th, 2018.

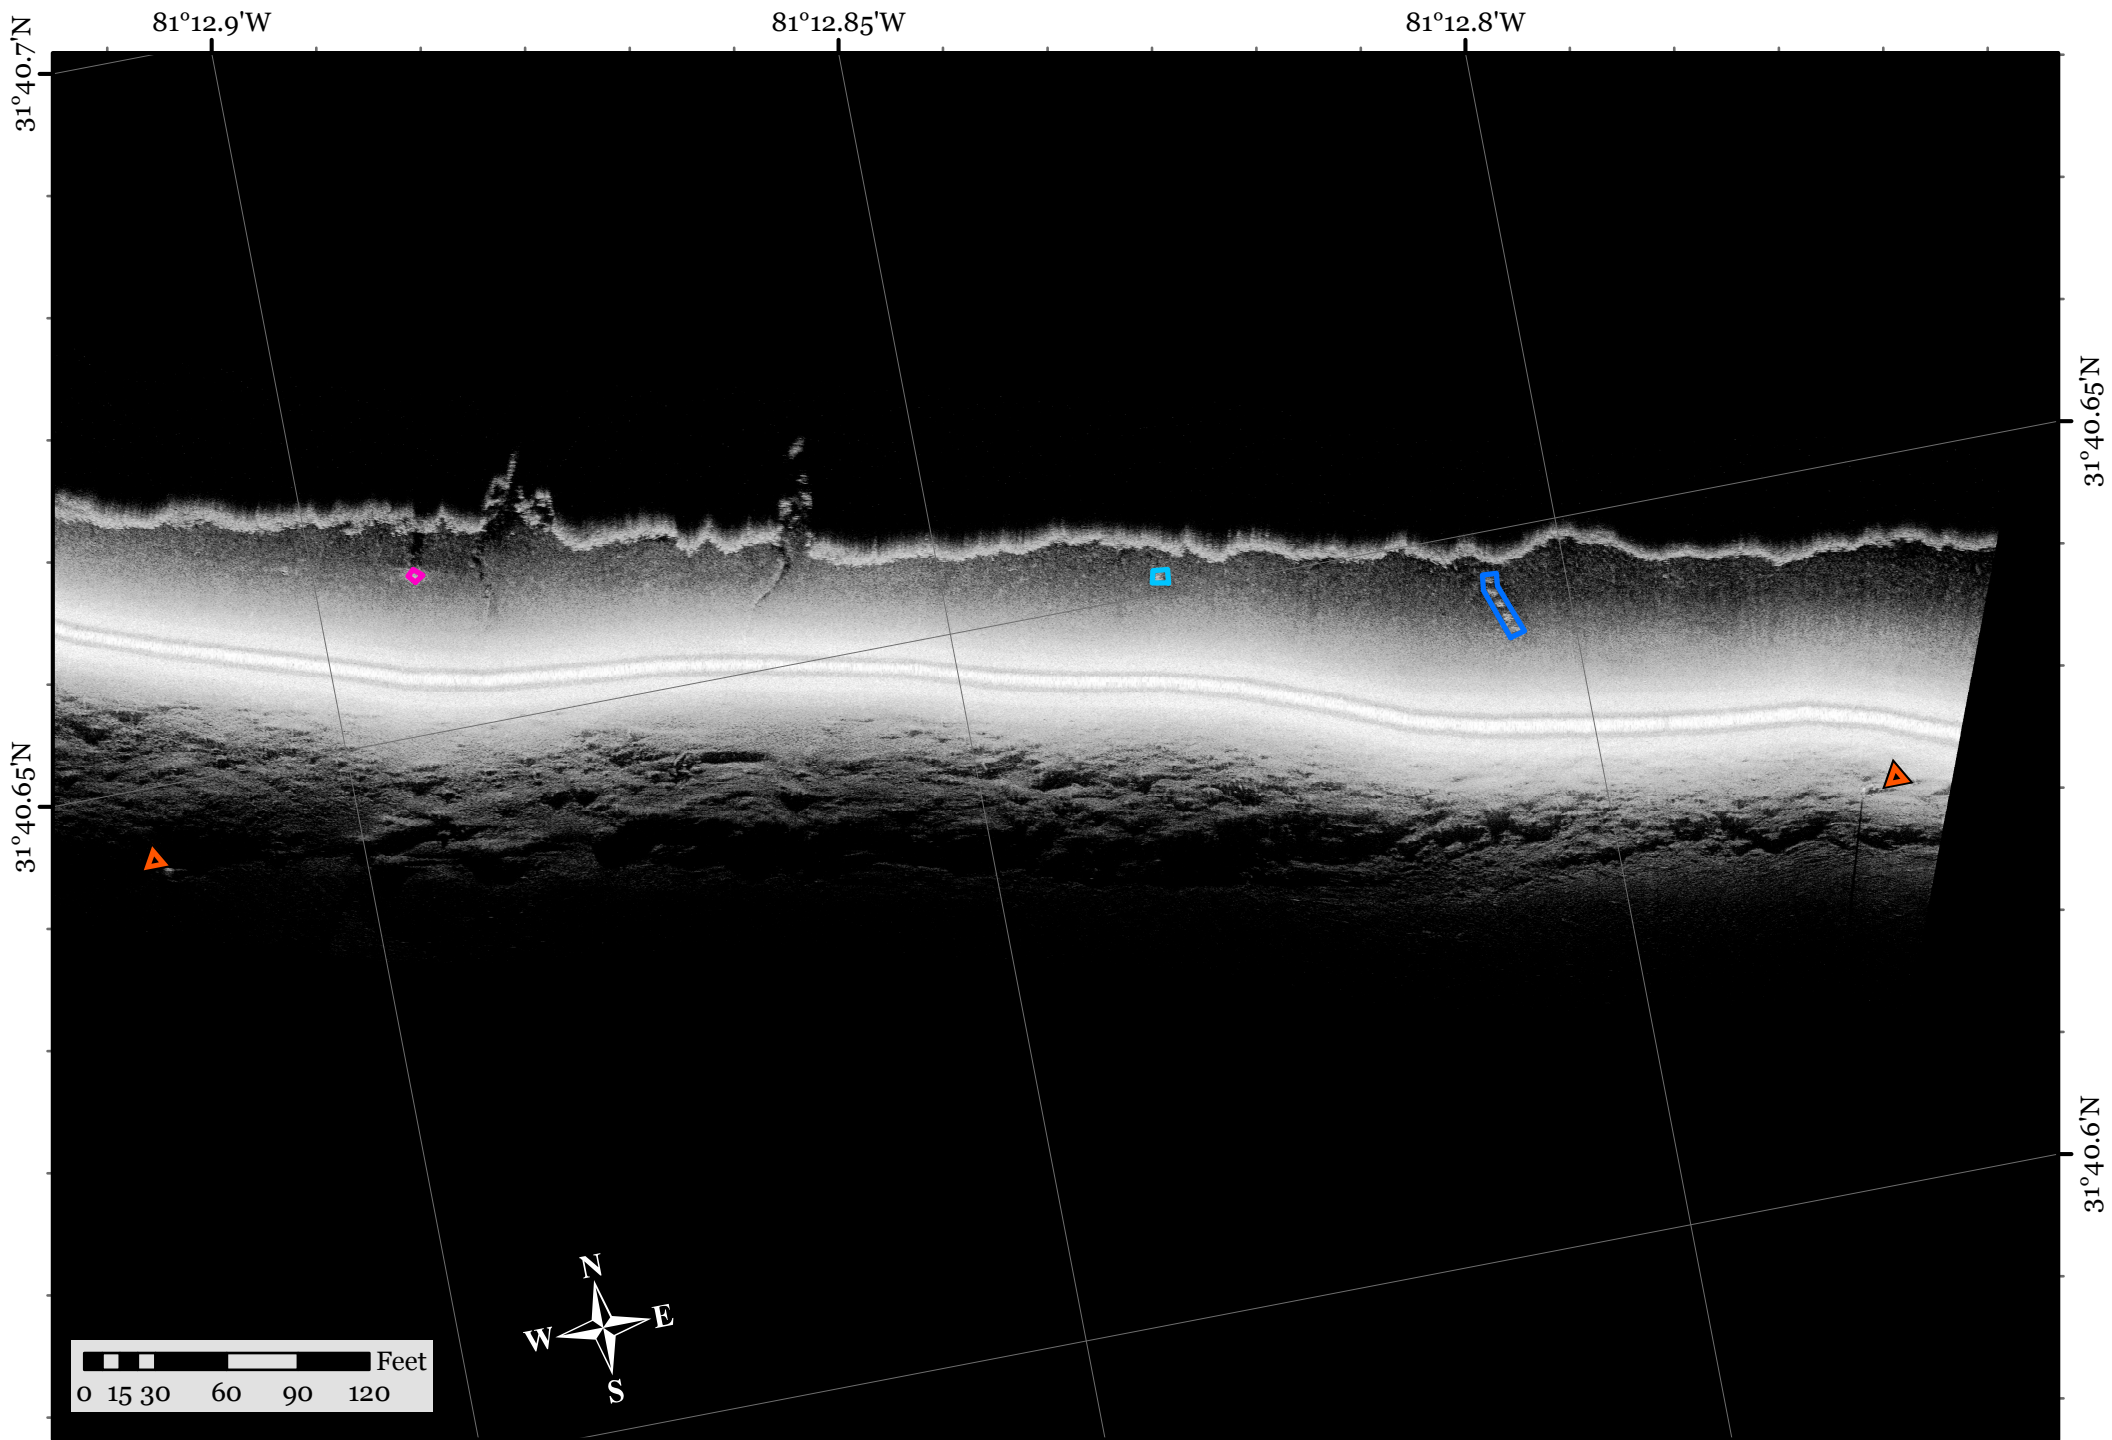
Pilings	 	Oyster Shell Bag
 	Fish Aggregating Device	 	Oyster Ball
