# Living shoreline added to Coastal HQ

By **MEGHAN ANGELINA**

WETLANDS BIOLOGIST  
COASTAL RESOURCES DIVISION

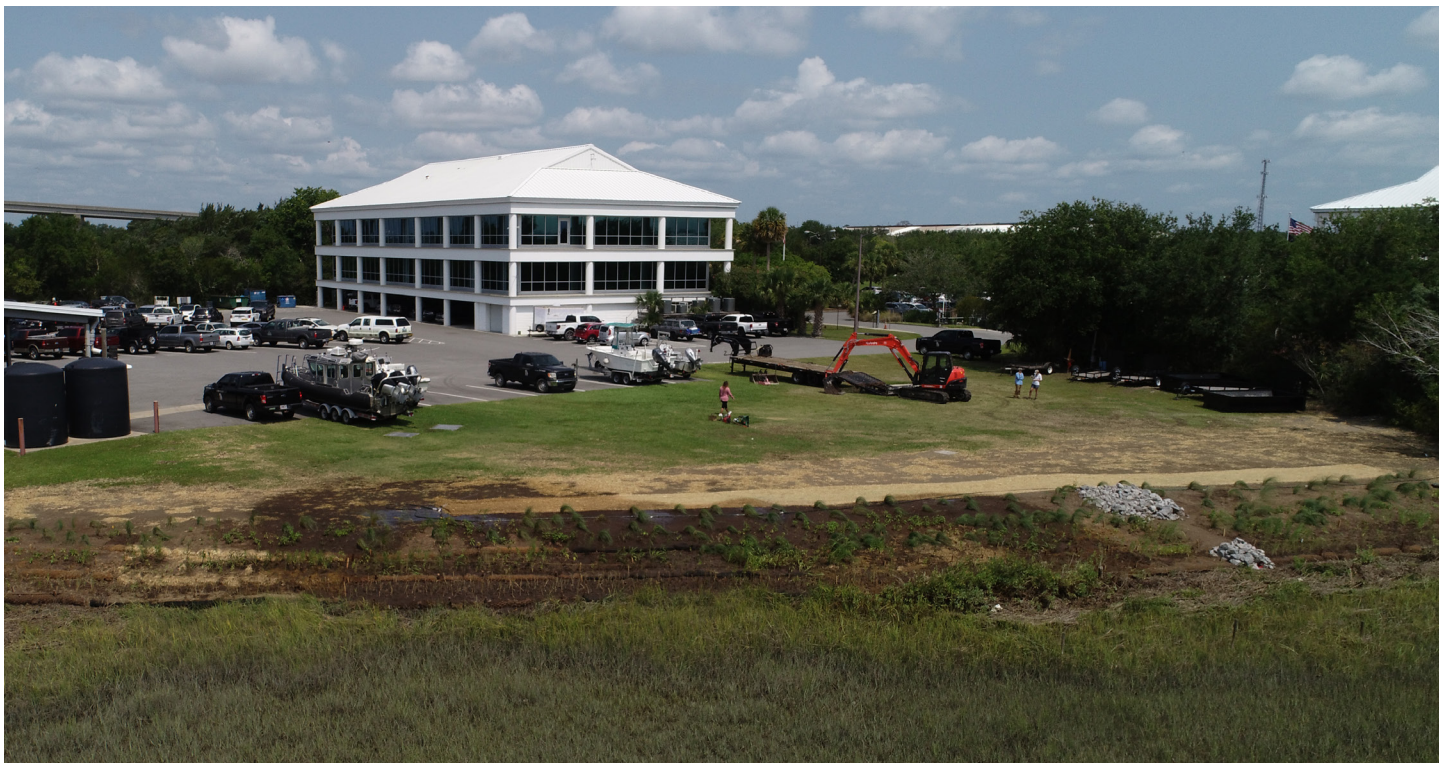
The new living shoreline at Coastal Regional Headquarters in Brunswick serving as a demonstration site for the continuous education of living shorelines in Georgia.

The living shoreline is 160 linear feet and separated into four, 40-foot sections, where two have a two-tiered design and the other two were graded to a 3:1 slope.

Dividing the shoreline into four sections allows for the demonstration of various methods and materials that can be used to construct a living shoreline. One of the tiered sections and one of the sloped sections use natural coir fiber erosion control mats and straw double layer jute mats where the others have no mats.

logs and Sox were placed at the “toe” of the shoreline, as well as at the bases of the top and middle tiers.

A stone infiltration trench was constructed along the top of the shoreline to absorb stormwater runoff. Diamondback terrapins have already used the living shoreline for upland access and nesting habitat.
